CRESTVIEW CONDOMINIUMS

Exterior Building Repair Project Summary

7/28/2022

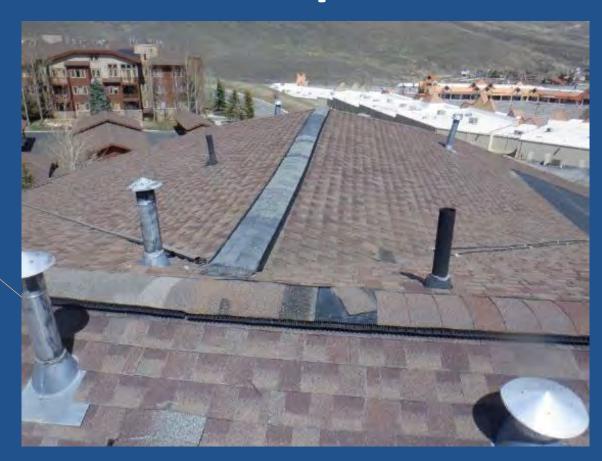
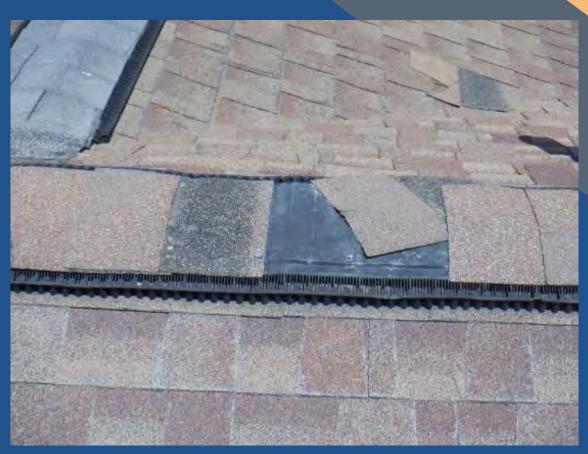
Granule loss and shingle damage

- Polymer-modified shingles
 - Heavy weight
 - Impact-resistant
 - Rubberizing polymers improve performance in temperature extremes
 - Increased granule adhesion
 - Enhanced crack resistance
- Ice Melt System
 - "Commercial Grade"
- Warranties
 - Roofing: 50 year limited transferable warranty against manufacturing defects;
 10 year "SureStart" warranty
 - o Ice Melt: 10 year warranty; 20 year expected useful life

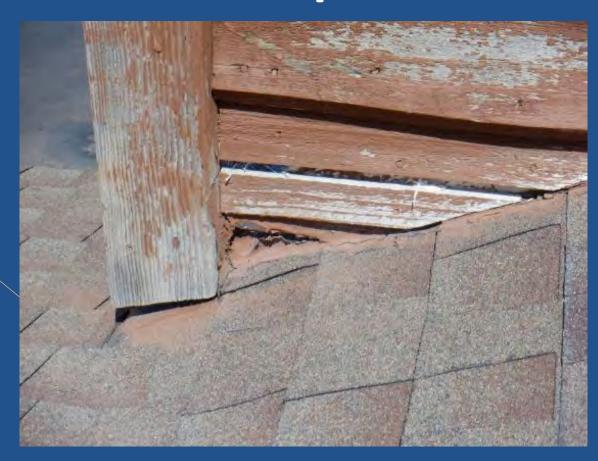
Improper roof-to-wall integration

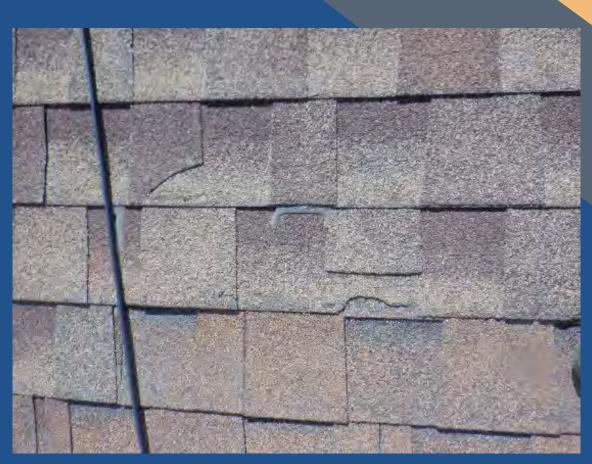
Granule loss and shingle damage

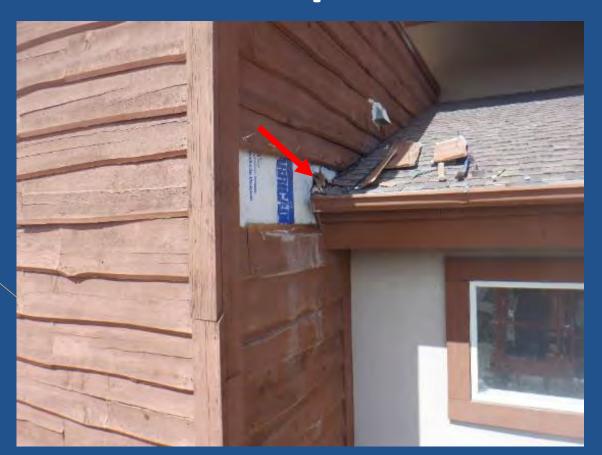
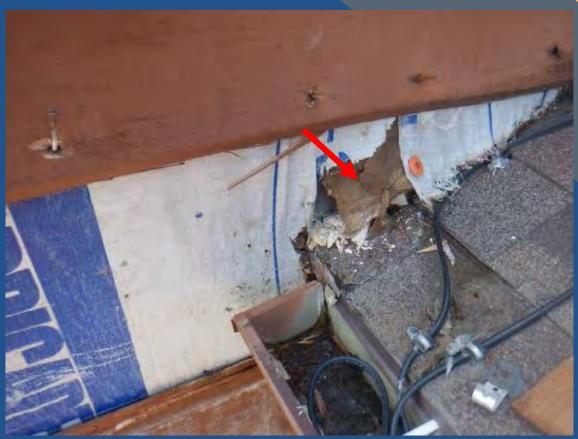
Improper diverter resulting in water intrusion at walls

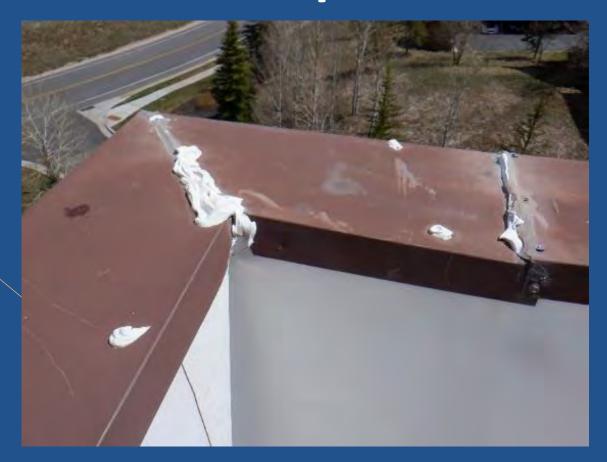
Sealant dependent coping (and improper sealant).

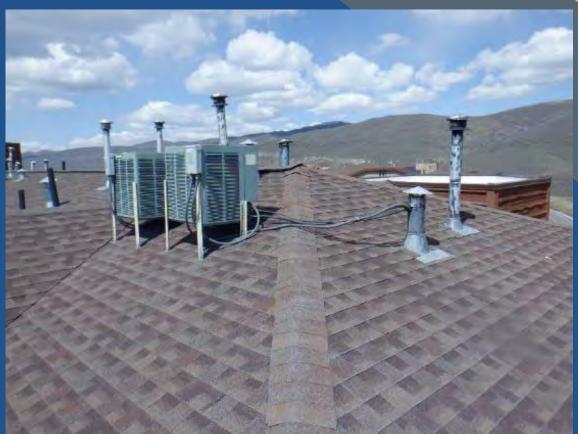
Improper mounting penetrations at rooftop mechanical equipment.

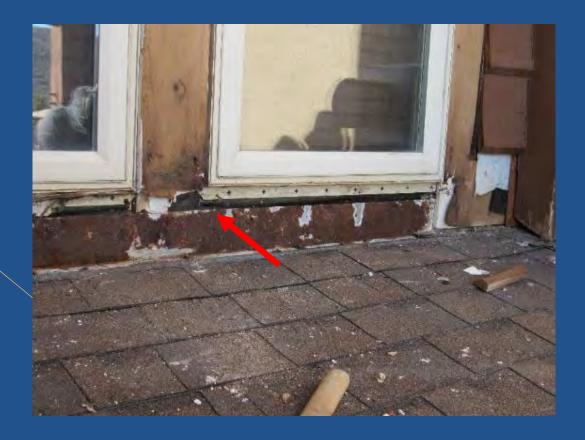
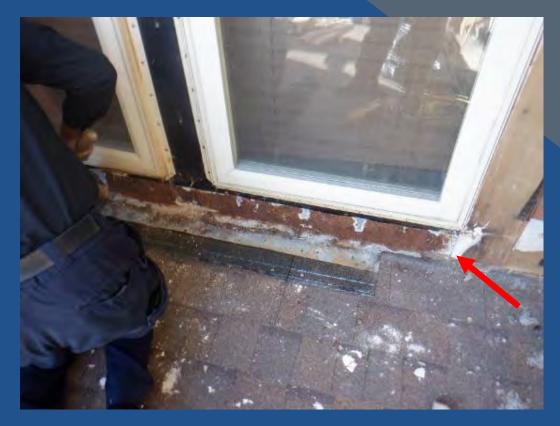
Improper and deteriorating flashing

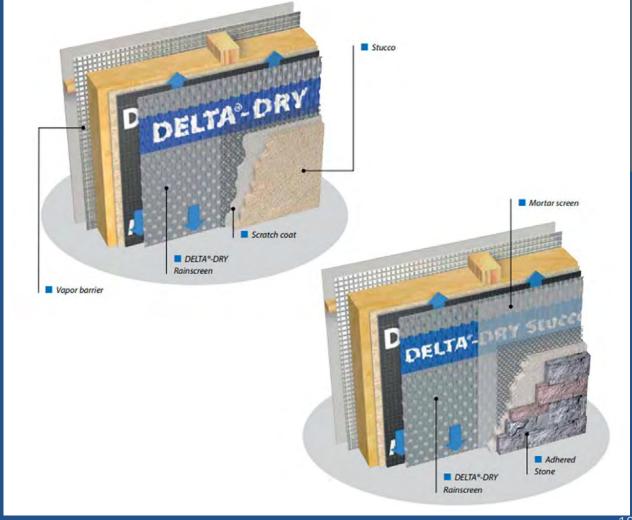
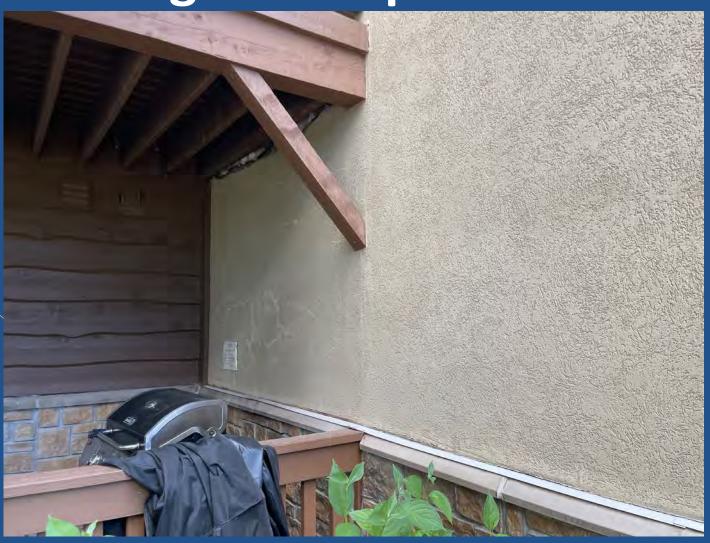
Deteriorated sheathing and WRB under deck ledger; stucco cracks

Replace stucco and stone veneer with new stucco and stone veneer over drainage medium/rainscreen system

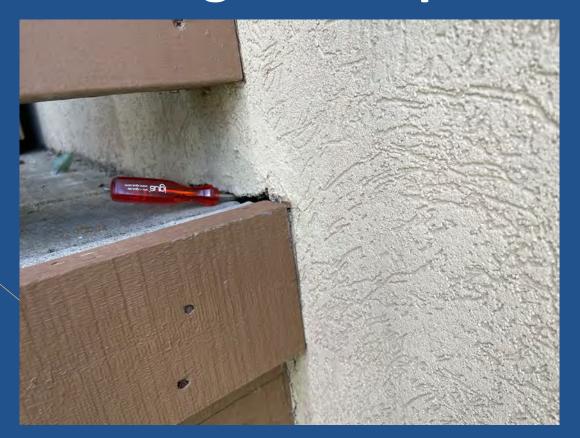
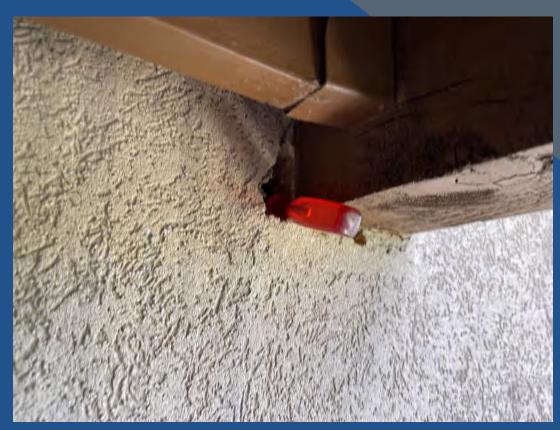
Open void into wall cavity at deck to wall locations

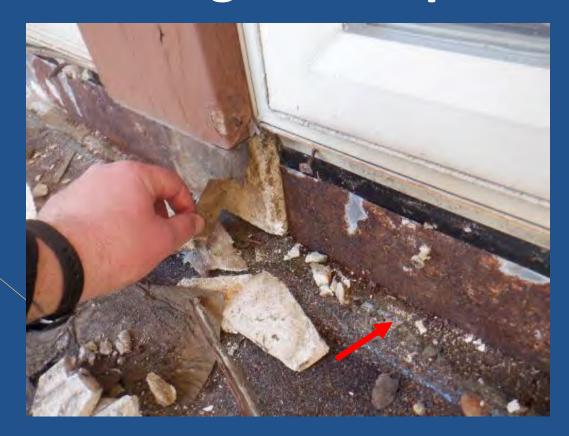
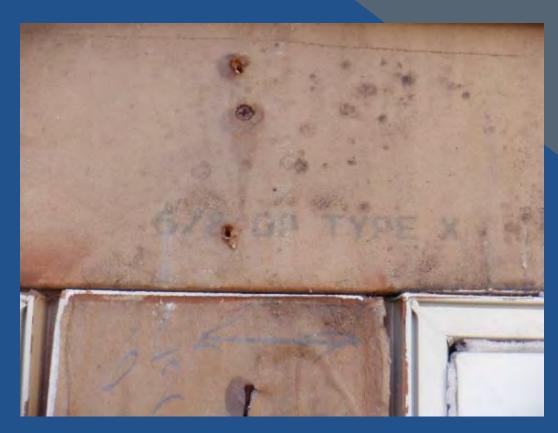
Water damaged WRB and sheathing

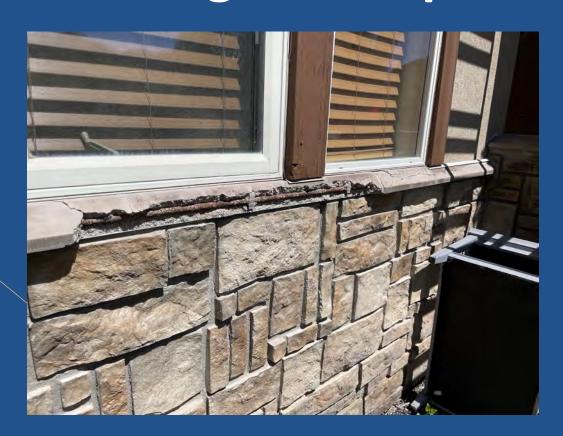
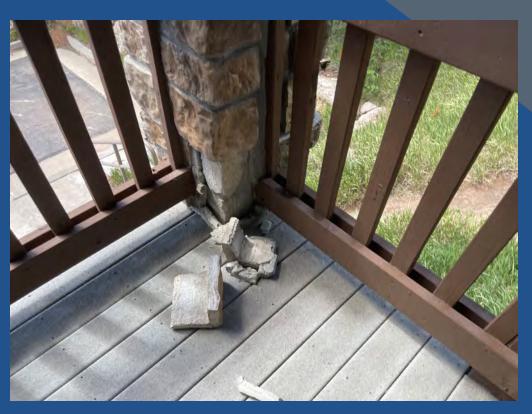
Deterioration of manufactured stone veneer; mortar/attachment failure of veneer

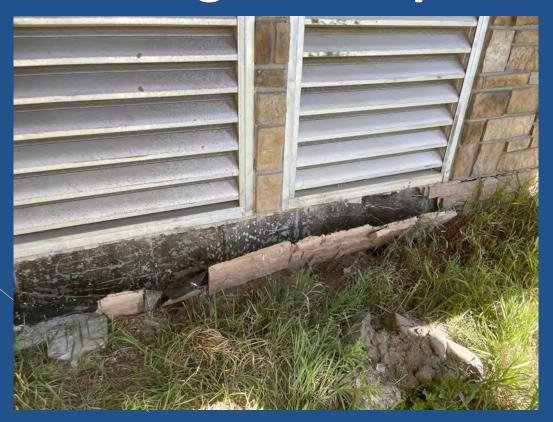
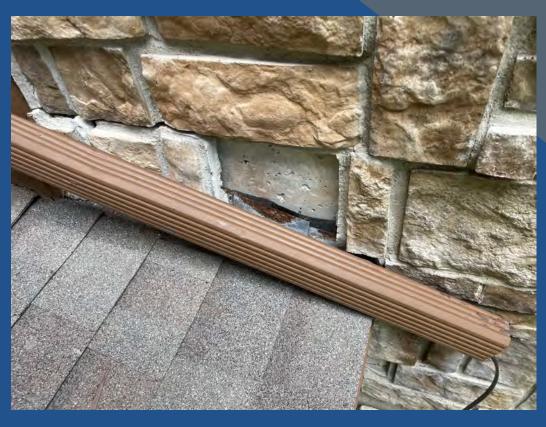
Manufactured stone veneer assembly failure

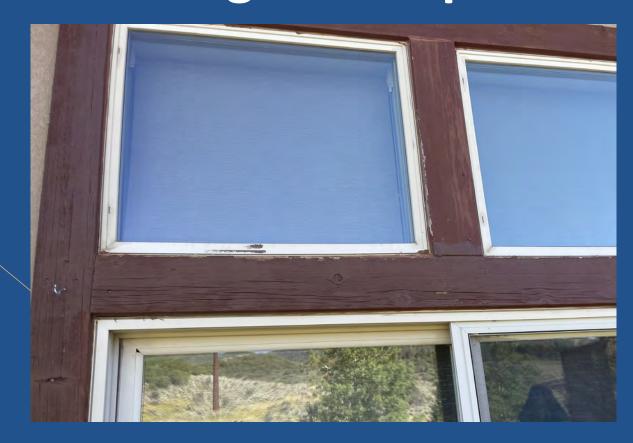
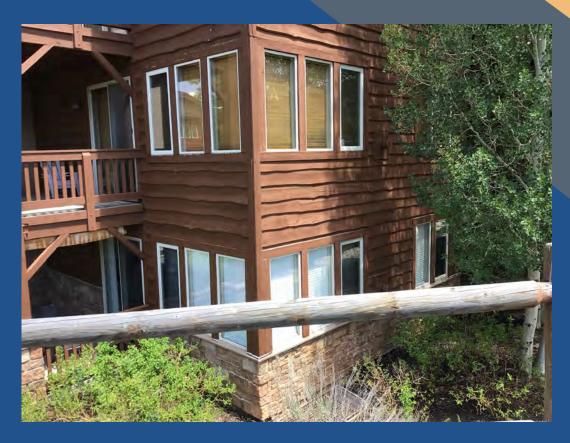
Weathered wood trim

High maintenance horizontal siding; prone to cracking, cupping and finish deterioration

Replace wood siding with fiber cement siding prefinished to look like stained wood

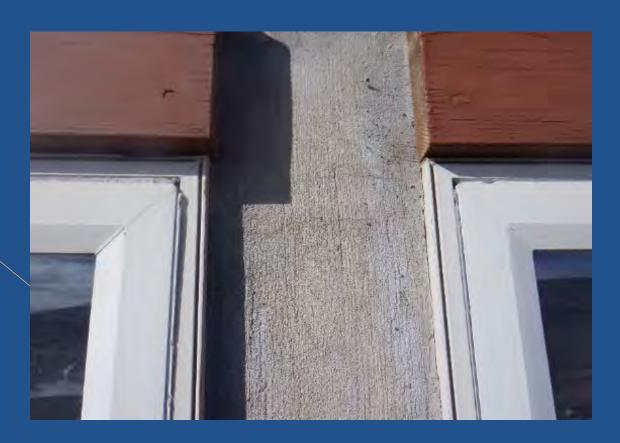
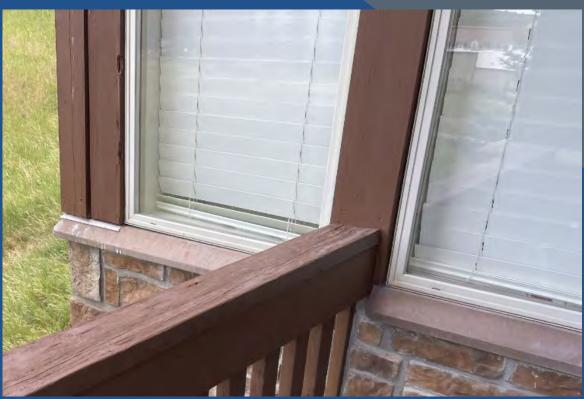
Omitted movement joints between window frames and adjacent cladding

Remove and replace existing windows

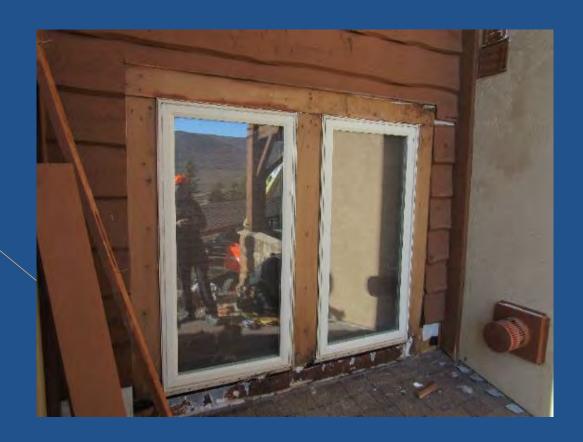
Omitted WRB behind window trim

Omitted SAF and sealant; improper fastening

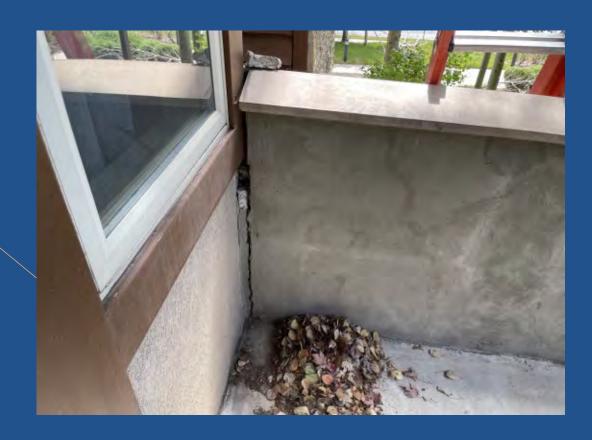
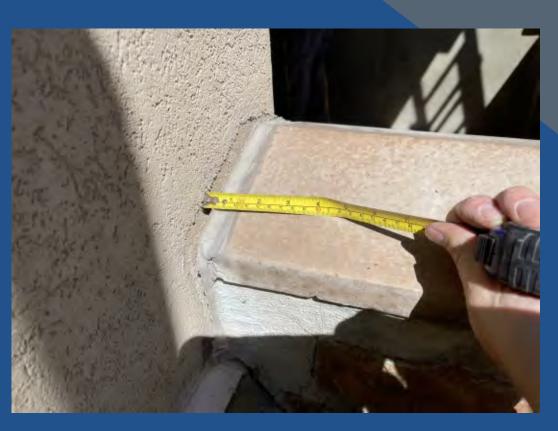
Lower floor patio wall pulling away from building due to foundation settling

Stabilize footings by "underpinning" decks with helical piers bolted to existing foundation

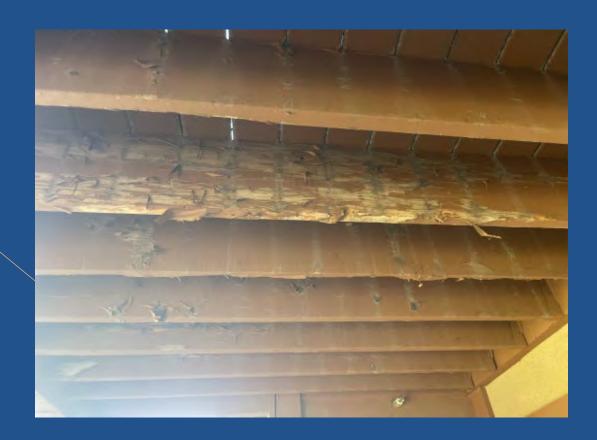
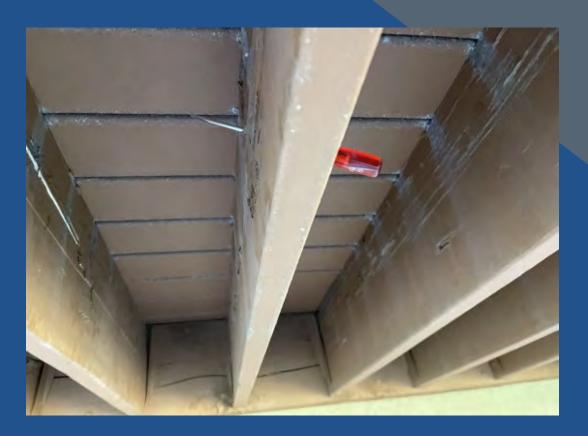
Decayed deck joists (35% +/-)

Replace existing framing with new preservative treated GLB timbers

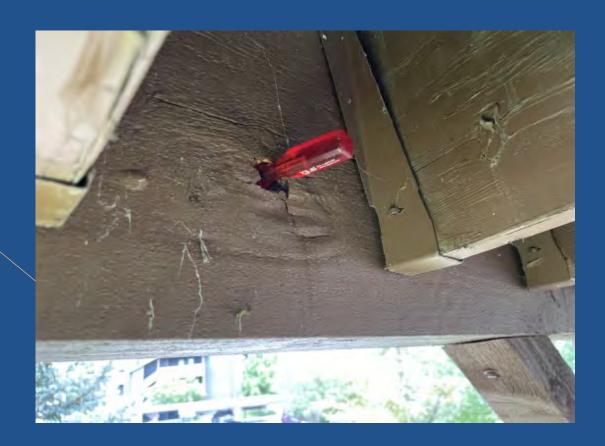
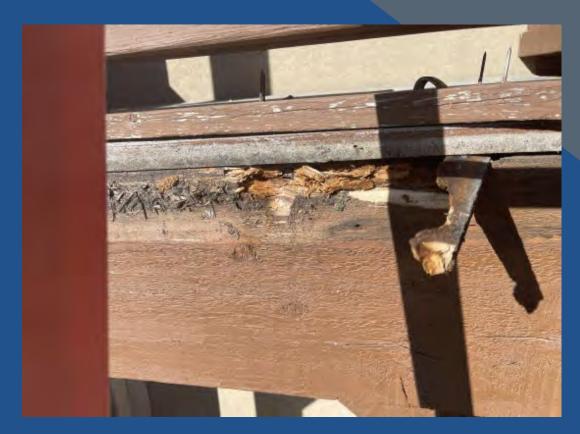
Decayed deck beams (10-20%)

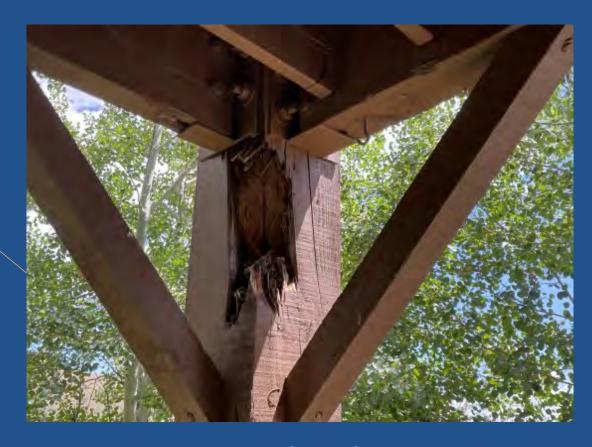
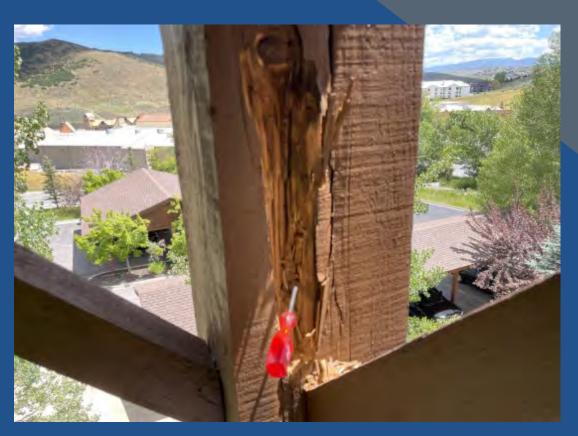
Decayed deck columns (30%+)

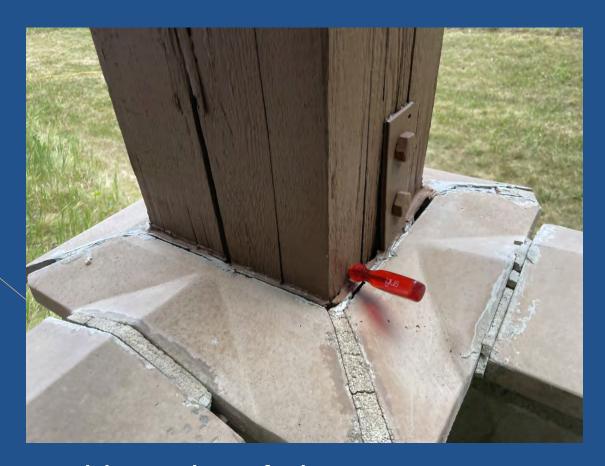
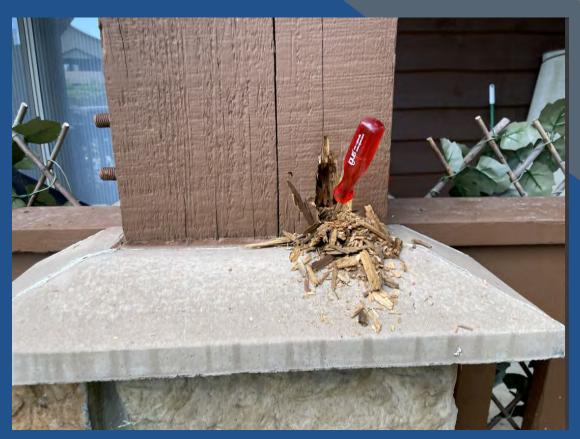
Wood decay at base of column

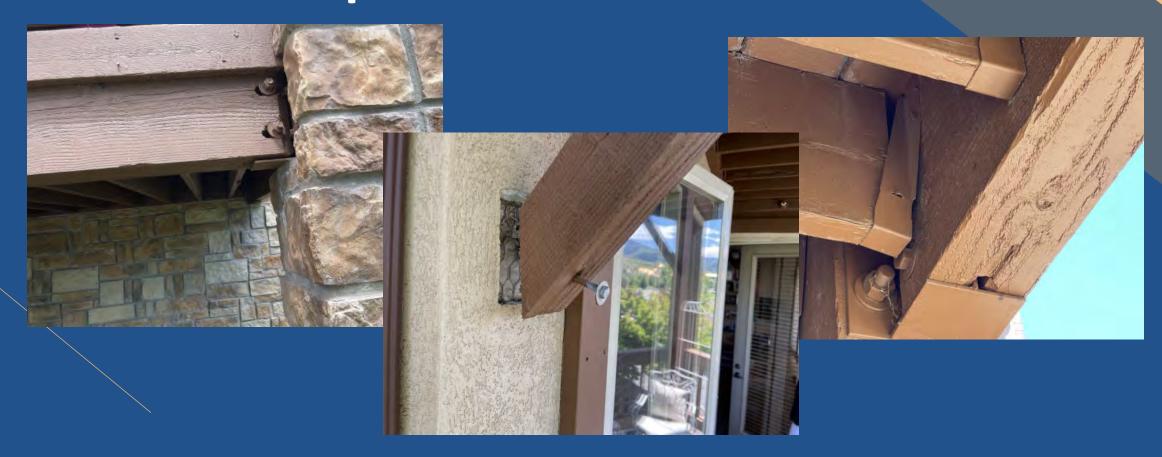
Deck connection failures

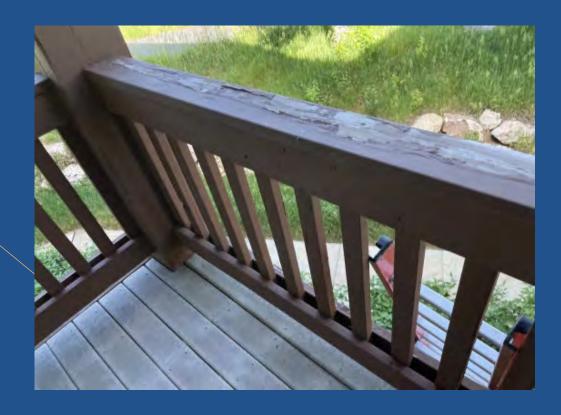
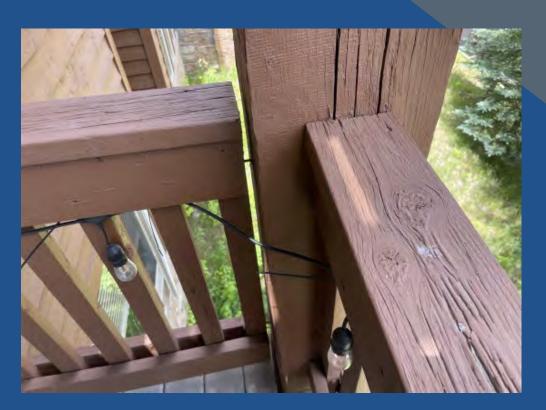
Weathered guardrail wood caps and paint

Inadequate guard attachment

Replace wood guards with powder coated aluminum guards
